Waves, Surge, and Damage on the Bolivar Peninsula During Hurricane Ike

Andrew Kennedy, Uriah Gravois, Brian Zachry, Spencer Rogers, Matild Dosa, Francisco Zarama, Jonathan Rager, and Asbury Sallenger

Summary

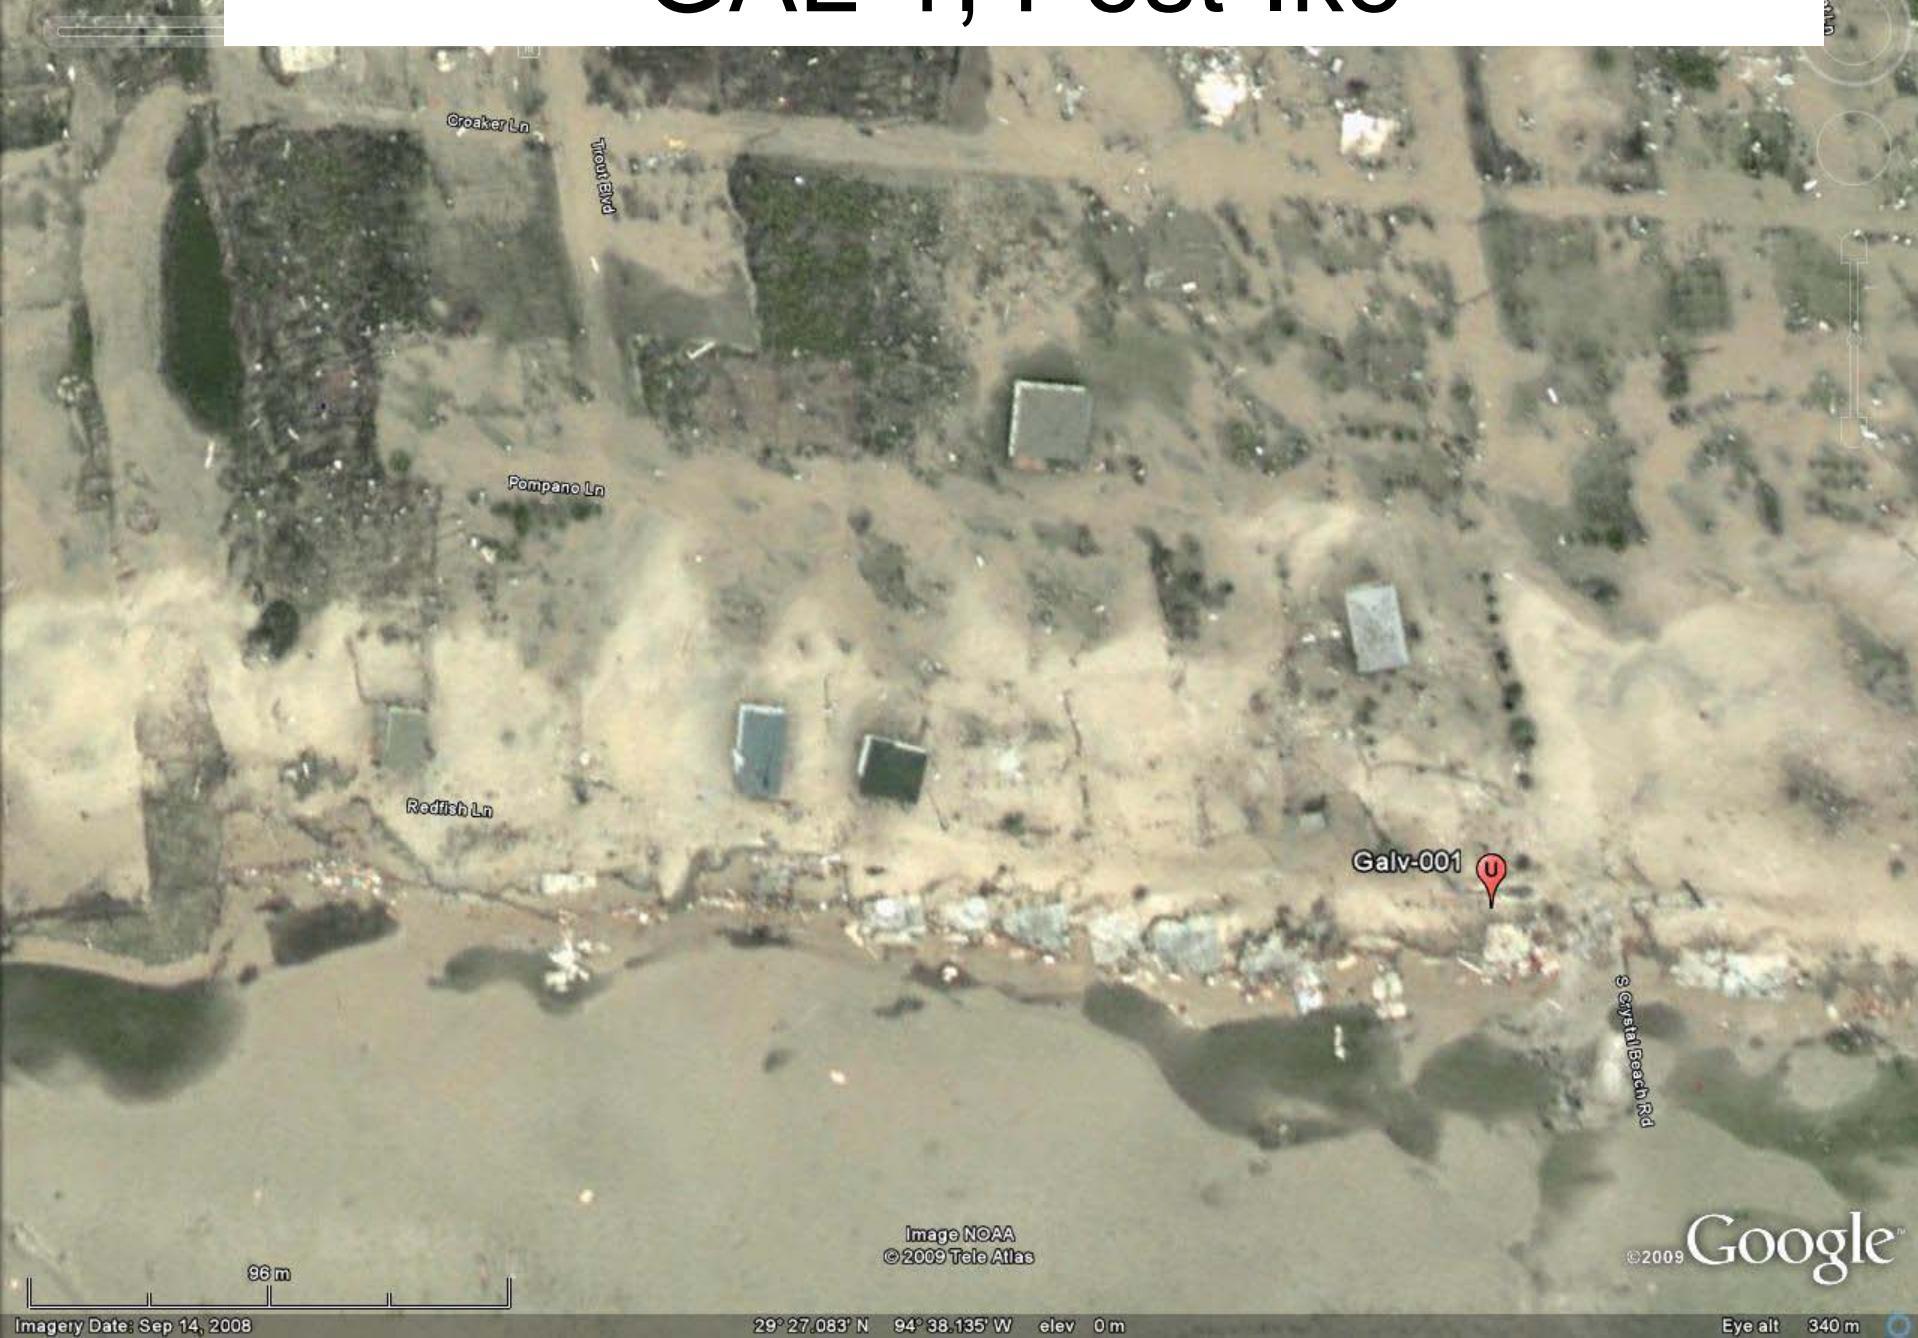
GAL-1, Post-Ike

- •Surge large at both gauges
- Large waves at GAL-1
- Very small waves at GAL-2
- •Near 6m wave plus surge crest inundation at GAL-1

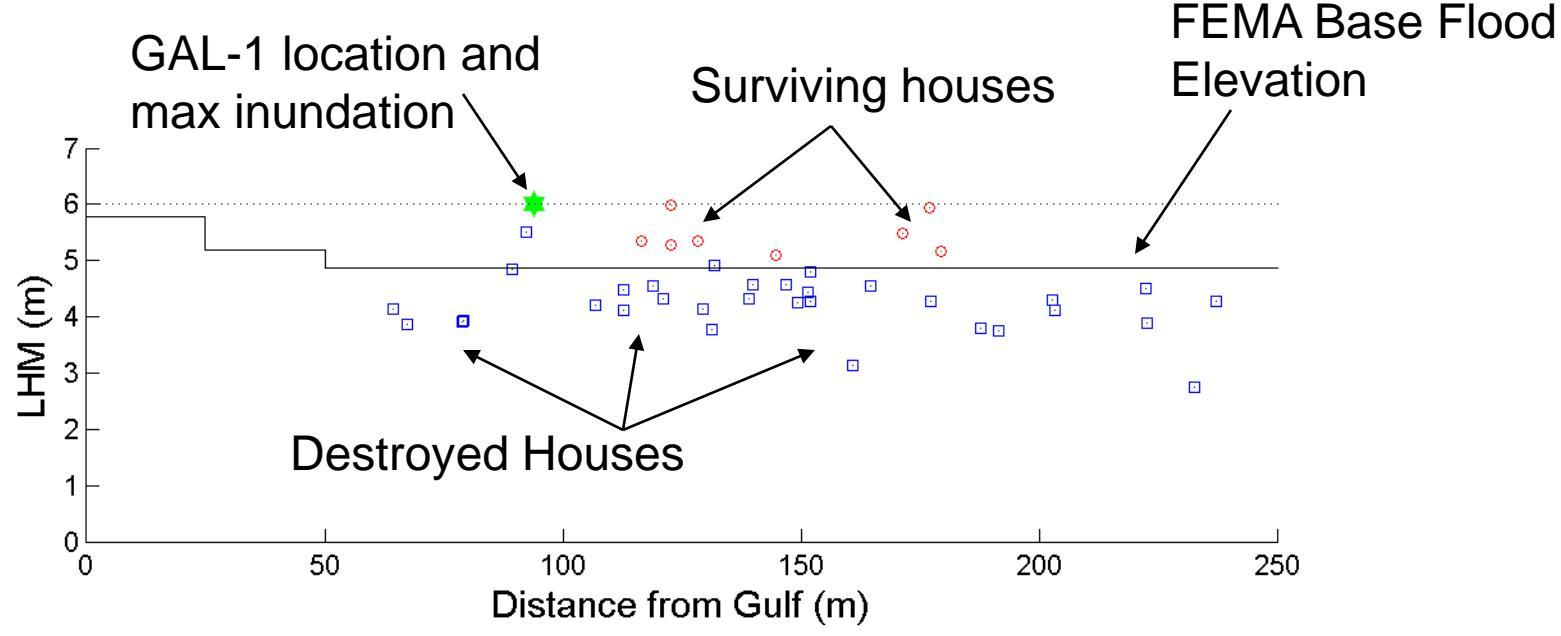
Wave Damage vs Building Elevation, GAL-1

•Survival or Destruction controlled by elevation of Lowest Horizontal Structural Member (LHM)

•Very narrow range in elevation between survival and destruction

•Large waves \rightarrow Hsmax = 1.8m at GAL-1

•FEMA Base Flood Elevation of 1992-1993 gives reasonable estimate of survival vs destruction here

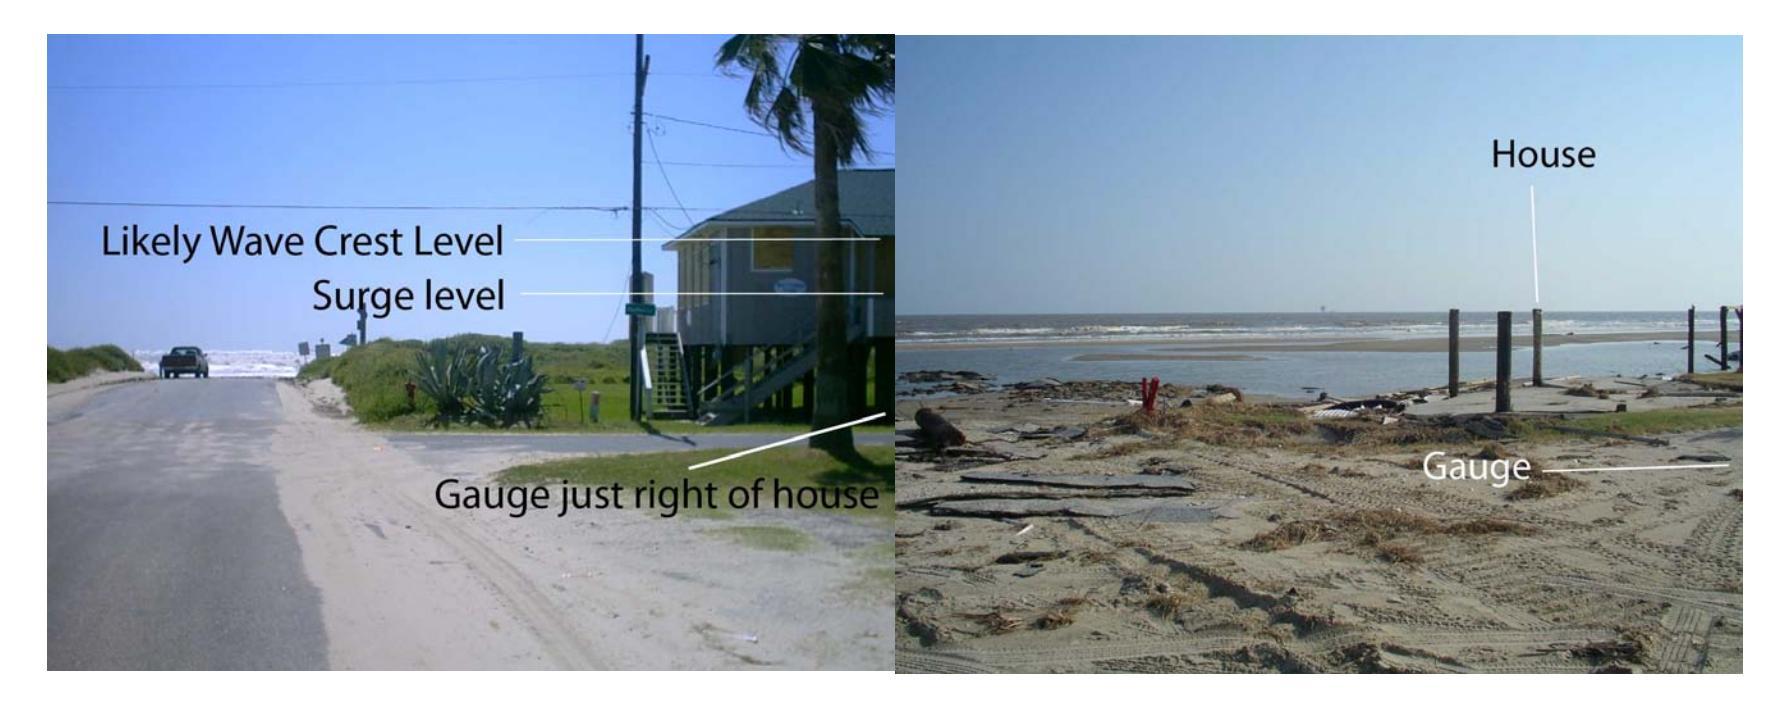
Ground Level Photos Near GAL-1

Immediately pre-lke

Post-Ike

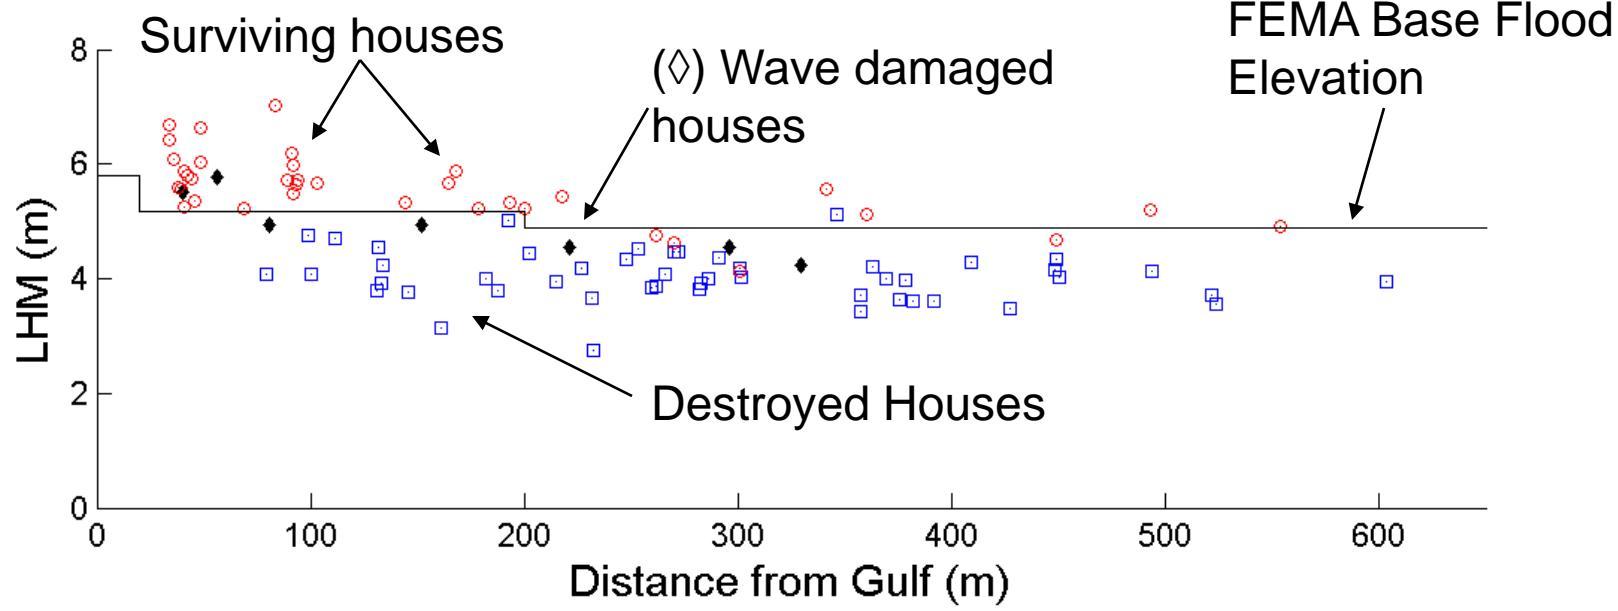
Damage at another Open Gulf Location

•Again very small range in elevation between survival and destruction (~0.5m)

- •Large waves here but exact heights uncertain
- •Similar results at many more open coast exposed locations

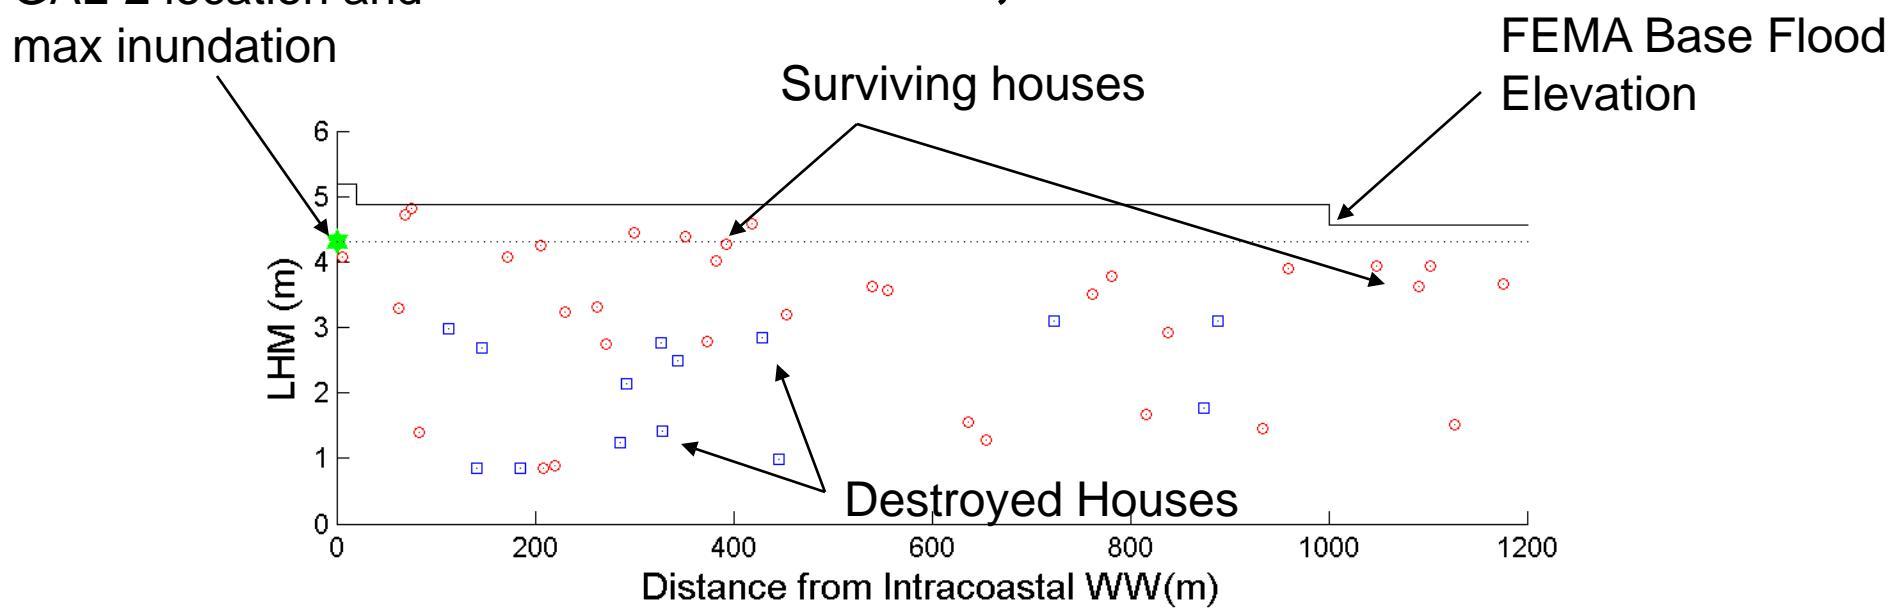
Wave Damage vs Building GAL-2 location and Elevation, GAL-2

•Survival can occur at any elevation

•No clear elevation dividing survival and destruction

•Small waves → Hsmax <0.2m at GAL-2

•FEMA Base Flood Elevation of 1992-1993 higher than elevation of many surviving buildings

•Supposed to be V-Zone (H>3ft) but no evidence of large waves

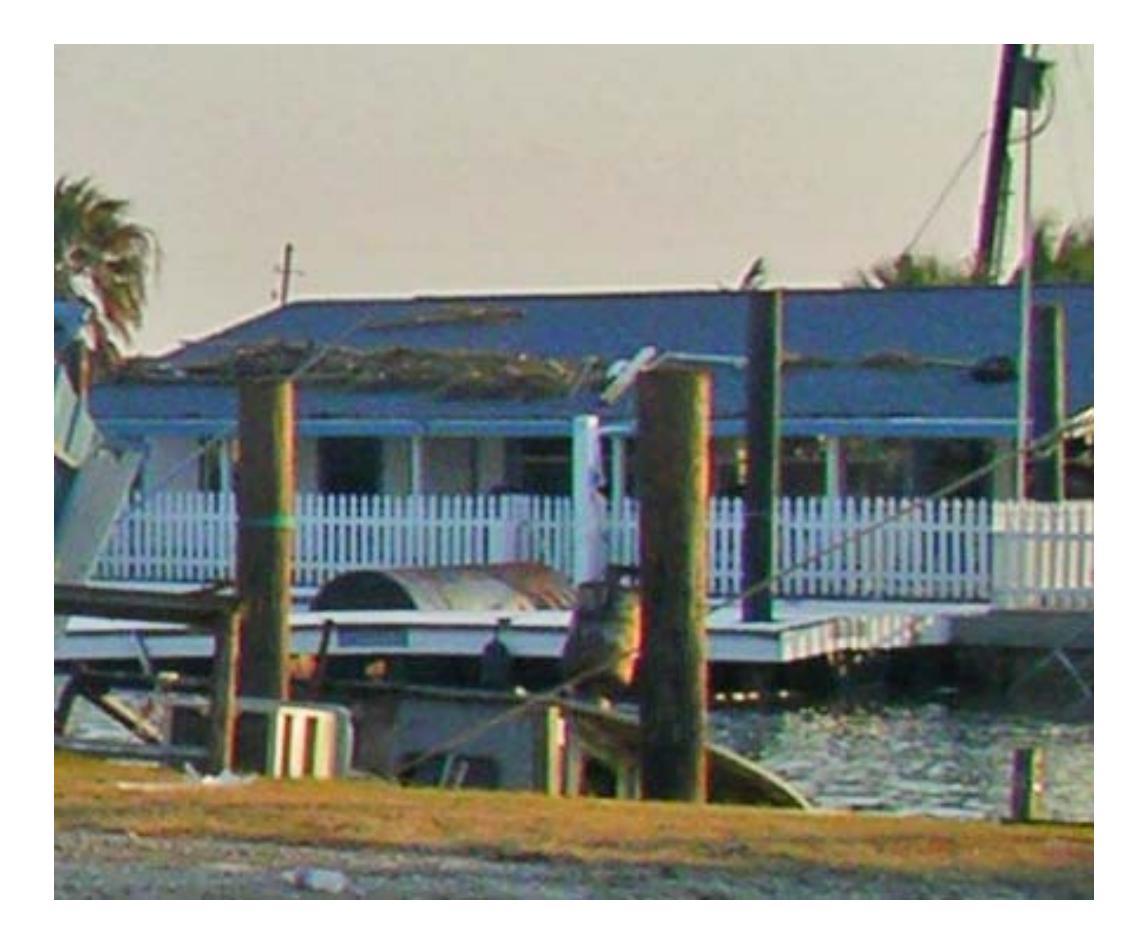
House Near GAL-2

At-grade house less than 100m from gauge GAL-2 on the Intracoastal Waterway. Note the flood debris on roof and survival of a flimsy picket fence. Photo courtesy of USGS.

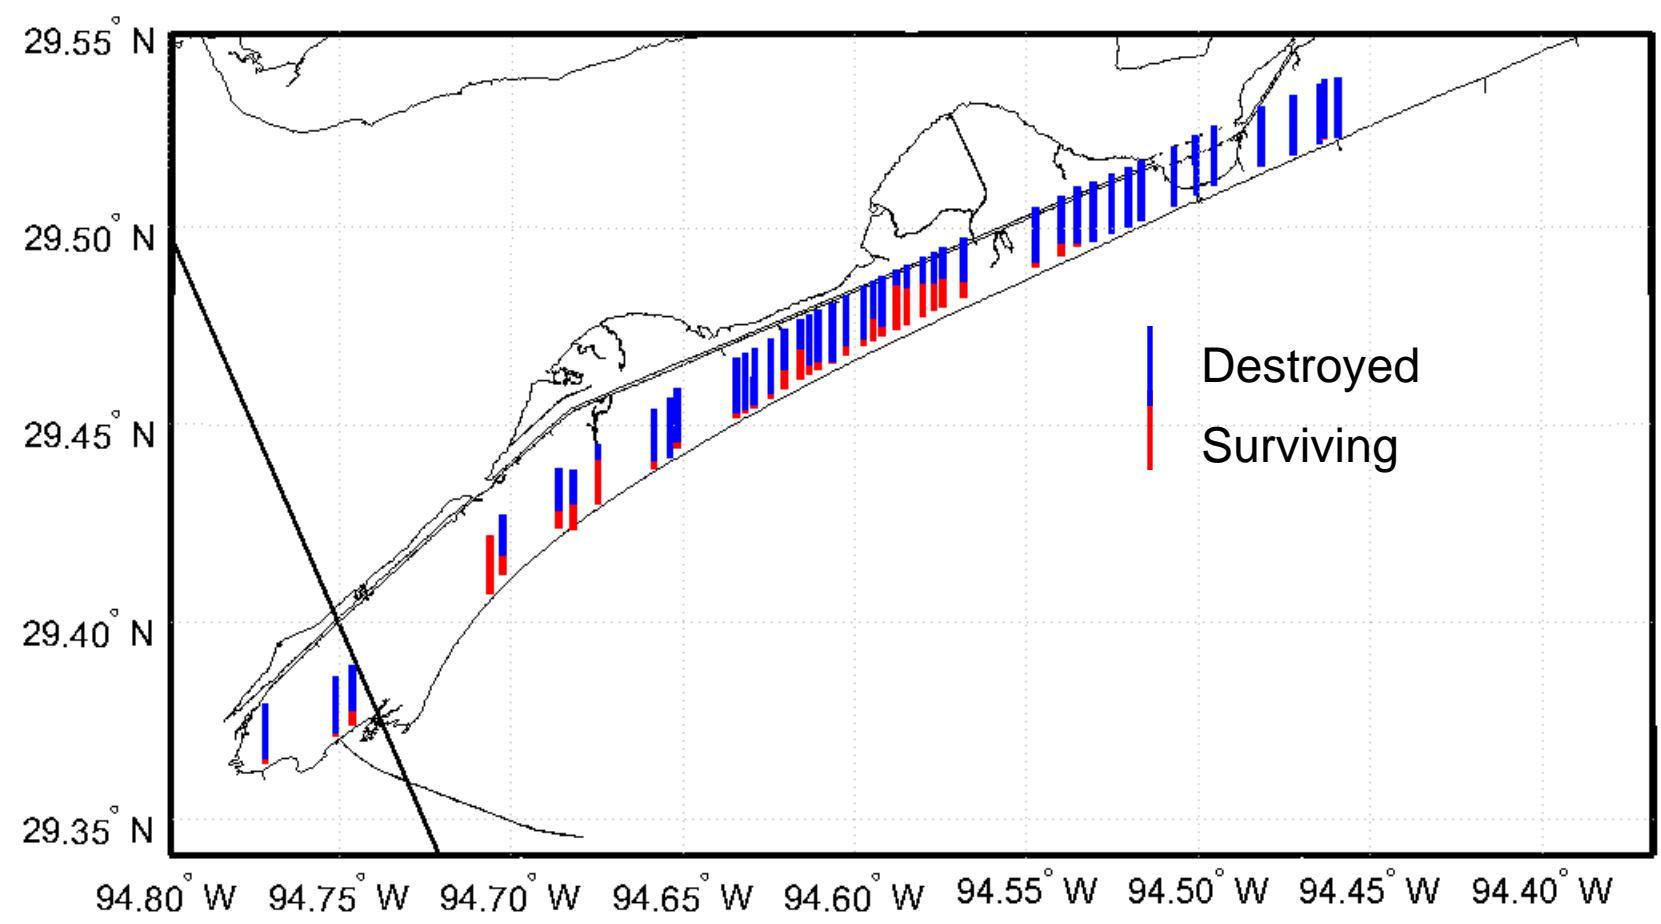
Overall Destruction Near Gulf Shoreline

•Very high destruction along entire shoreline – varies by location and elevation of construction

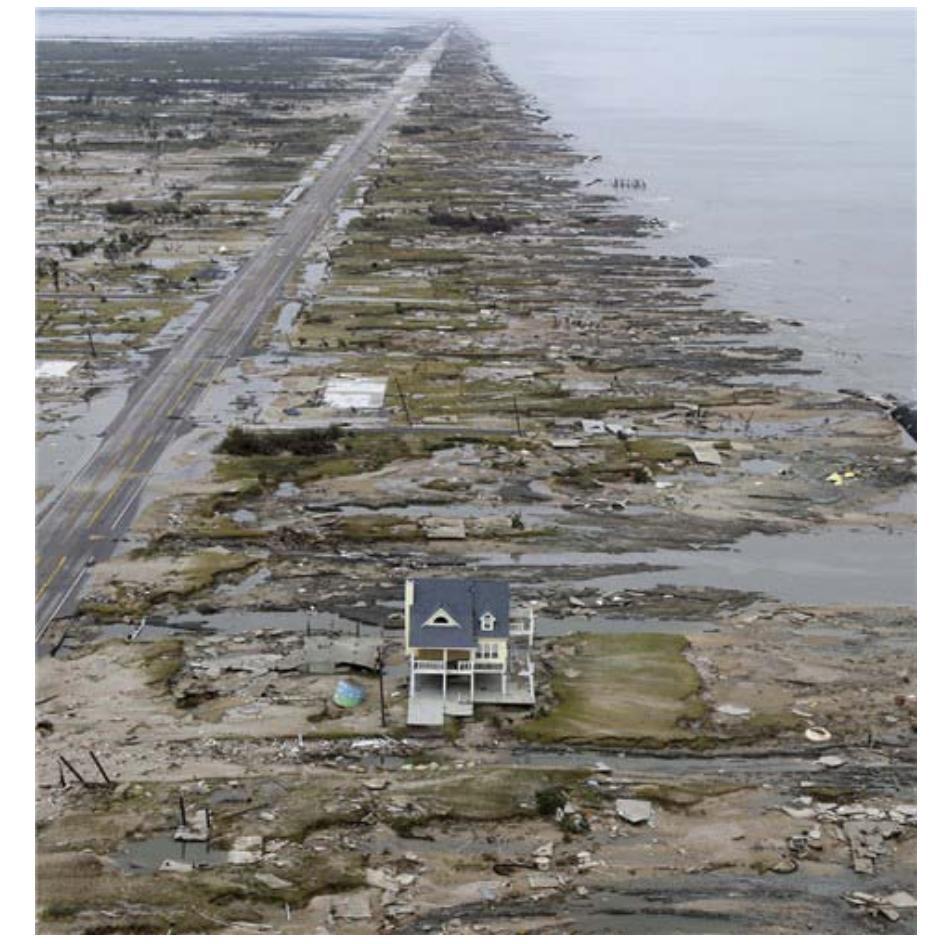
Last House Standing Photo: Ray Asgar, Helicopter Pilot
