Waves, Surge, and Damage on the Bolivar Peninsula During Hurricane Ike

Andrew Kennedy, Uriah Gravois, Brian Zachry, Spencer Rogers, Matild Dosa, Francisco Zarama, Jonathan Rager, and Asbury Sallenger

Summary

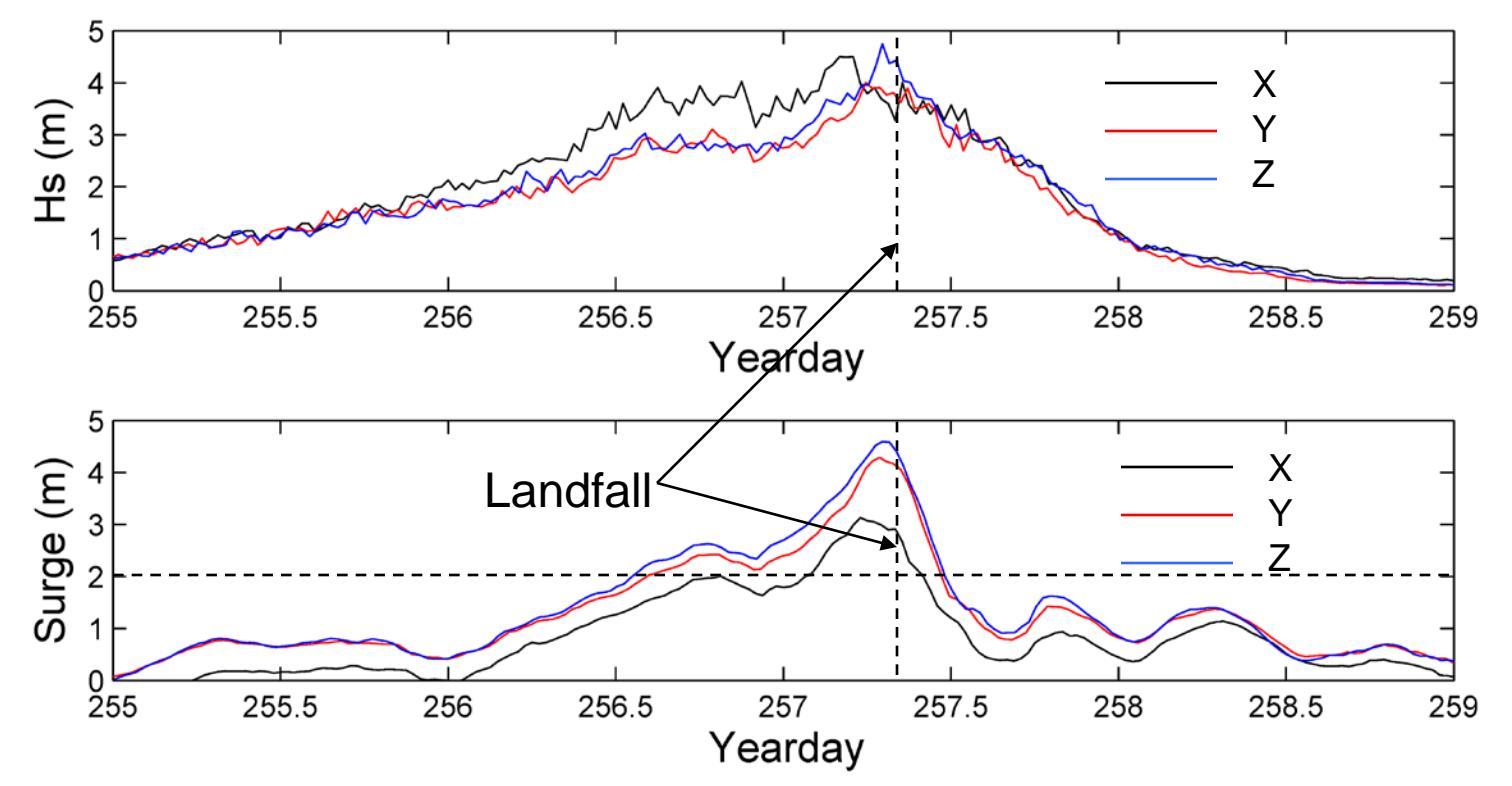
Waves and Surge in ~9m Depth

•Waves on strong side (Y,Z) were large and close to equilibrium with local winds

•Waves near landfall (X) were a combination of swell and sea

•Surge exceeded 2m NAVD88 around 18 hours before landfall

Likely caused by Coriolis effect from ~1m/s longshore current

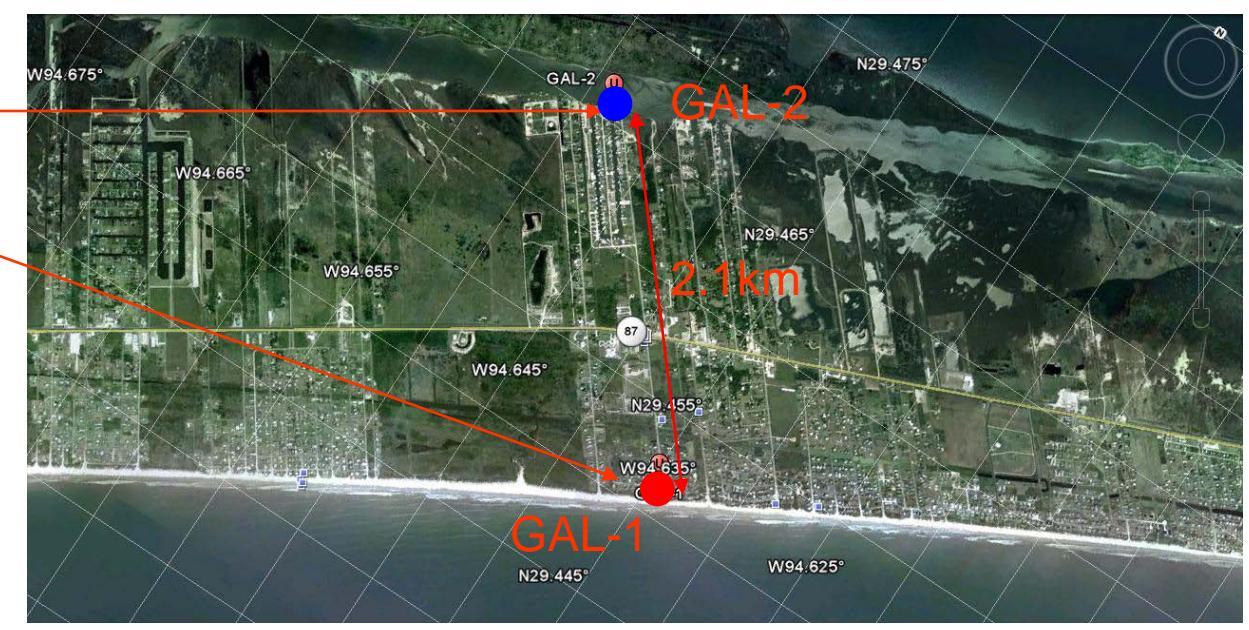
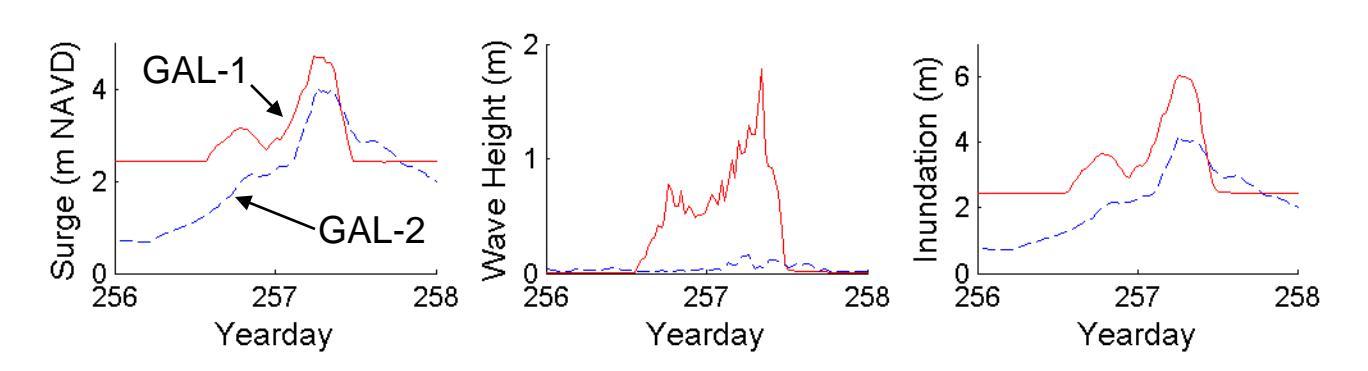
Overland Waves and Surge

- •Surge large at both gauges
- Large waves at GAL-1
- Very small waves at GAL-2
- •Near 6m wave plus surge crest inundation at GAL-1

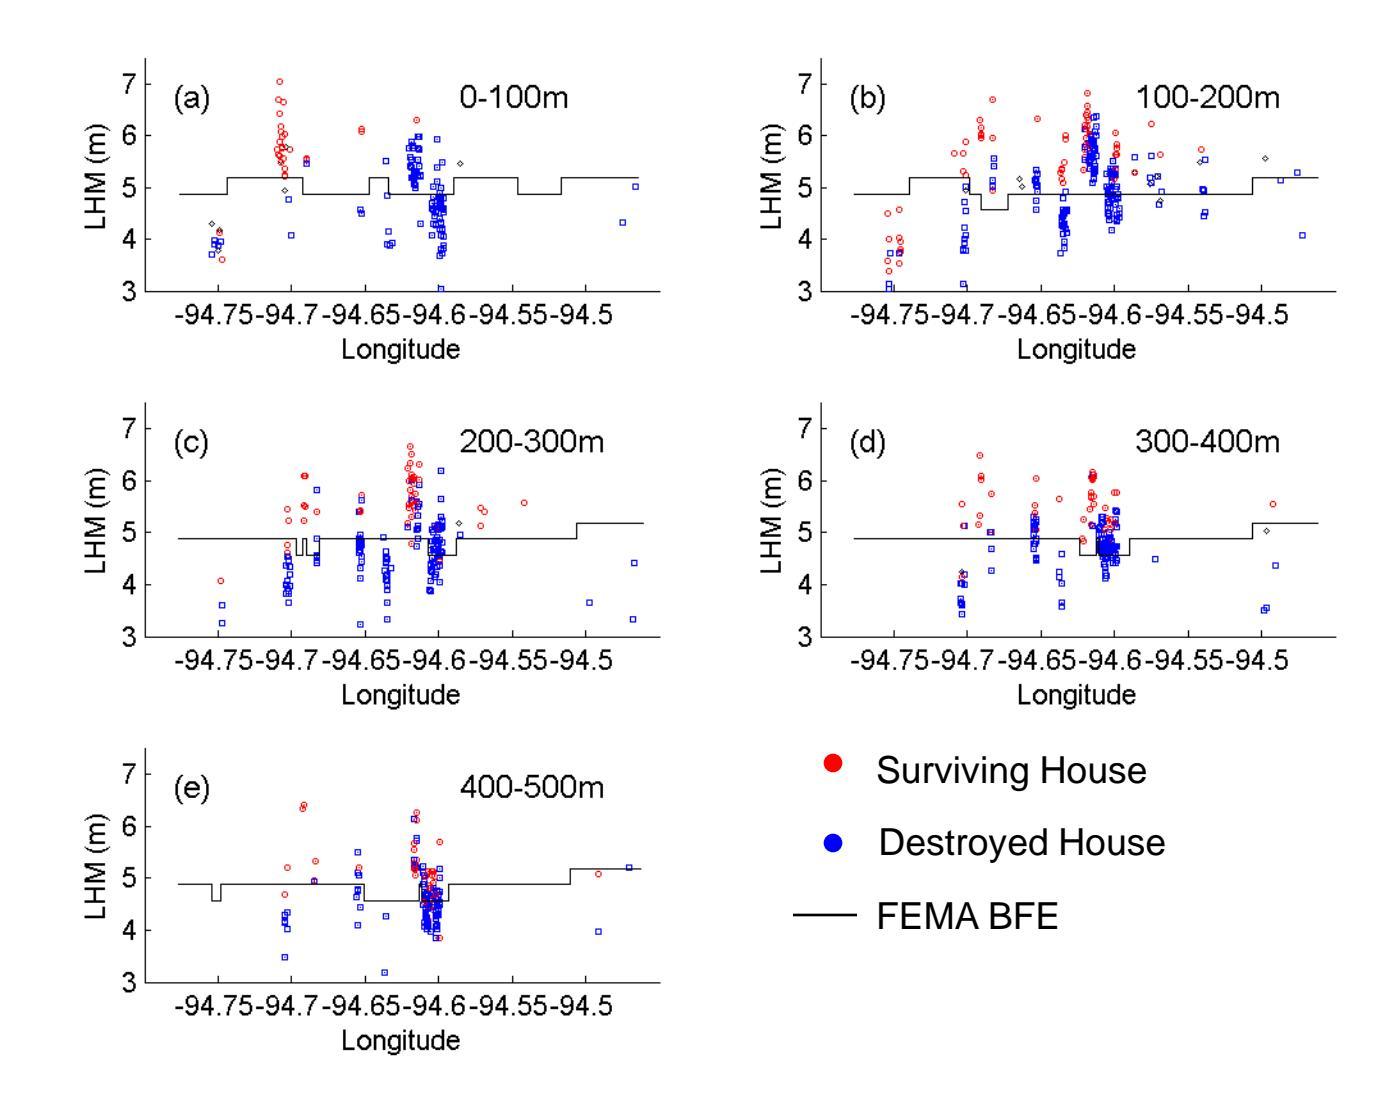
Survival vs Elevation near Gulf Shoreline

•Very high destruction along entire shoreline – varies by location and elevation of construction
